NASA CR-144971  
JAN 9, 1976

# YF-12 LOCKALLOY VENTRAL FIN PROGRAM FINAL REPORT

## VOLUME 1

**LOCKHEED-CALIFORNIA COMPANY**

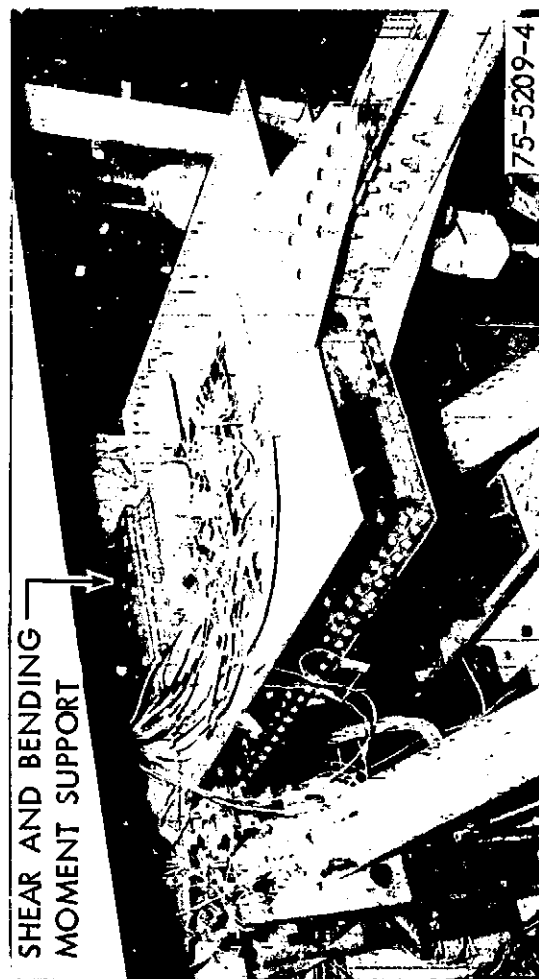
1063-4

- TEST SPECIMEN DUPLICATES FRONT BEAM AND ROOT JOINT OF THE VENTRAL
- SIMULATED SURFACE STRESSES ARE MAXIMUM AT THIS LOCATION
- FAILURE STRESS VERIFIED PREDICTED STRESS
- FAILURE OCCURRED BY COLLAPSE OF THE TITANIUM SUPPORT CHANNELS, ALLOWING SIMULATED LOCKALLOY PANELS TO BUCKLE IN COMPRESSION.
